**Edwards Aquifer Habitat Conservation Plan  
Expanded Water Quality Monitoring Report**

**January 2017**

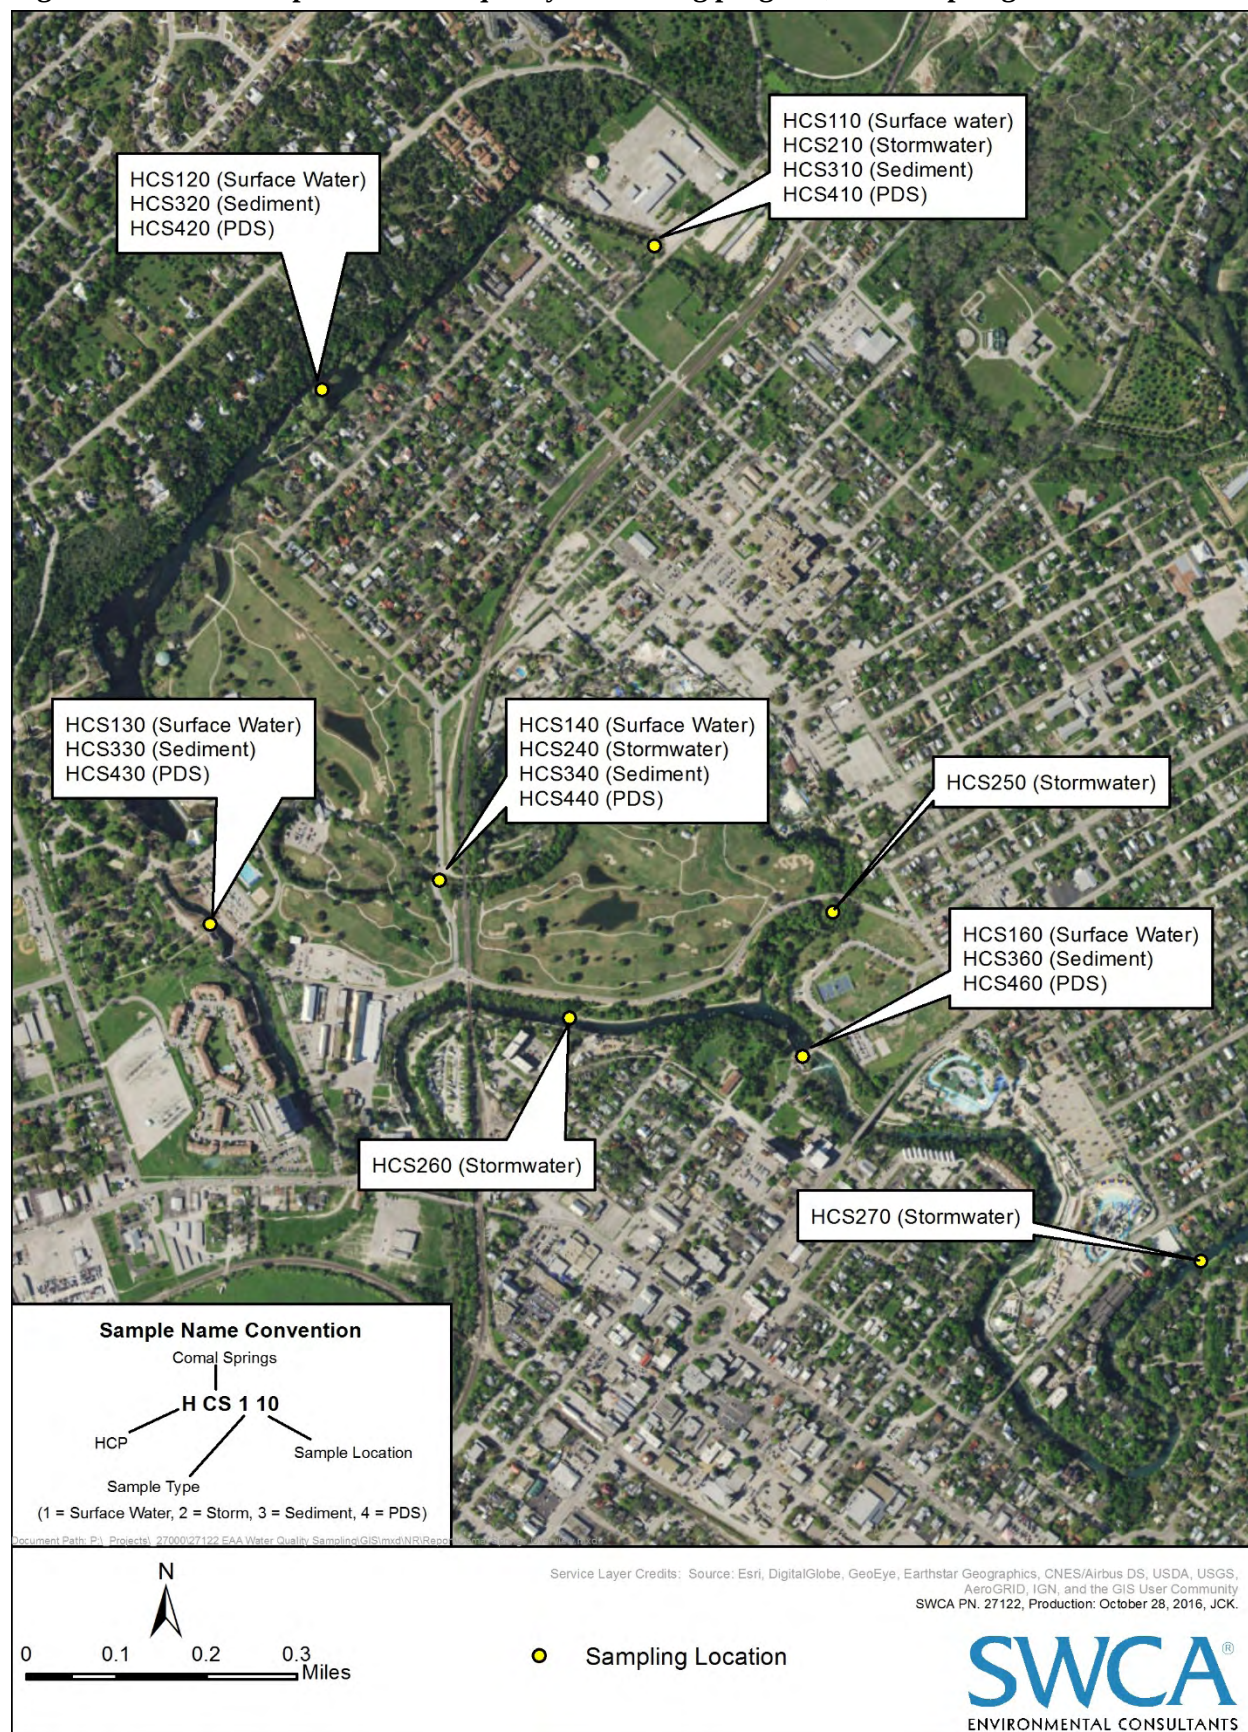
**Figure 1. EAHCP expanded water quality monitoring program, Comal Springs and River.**

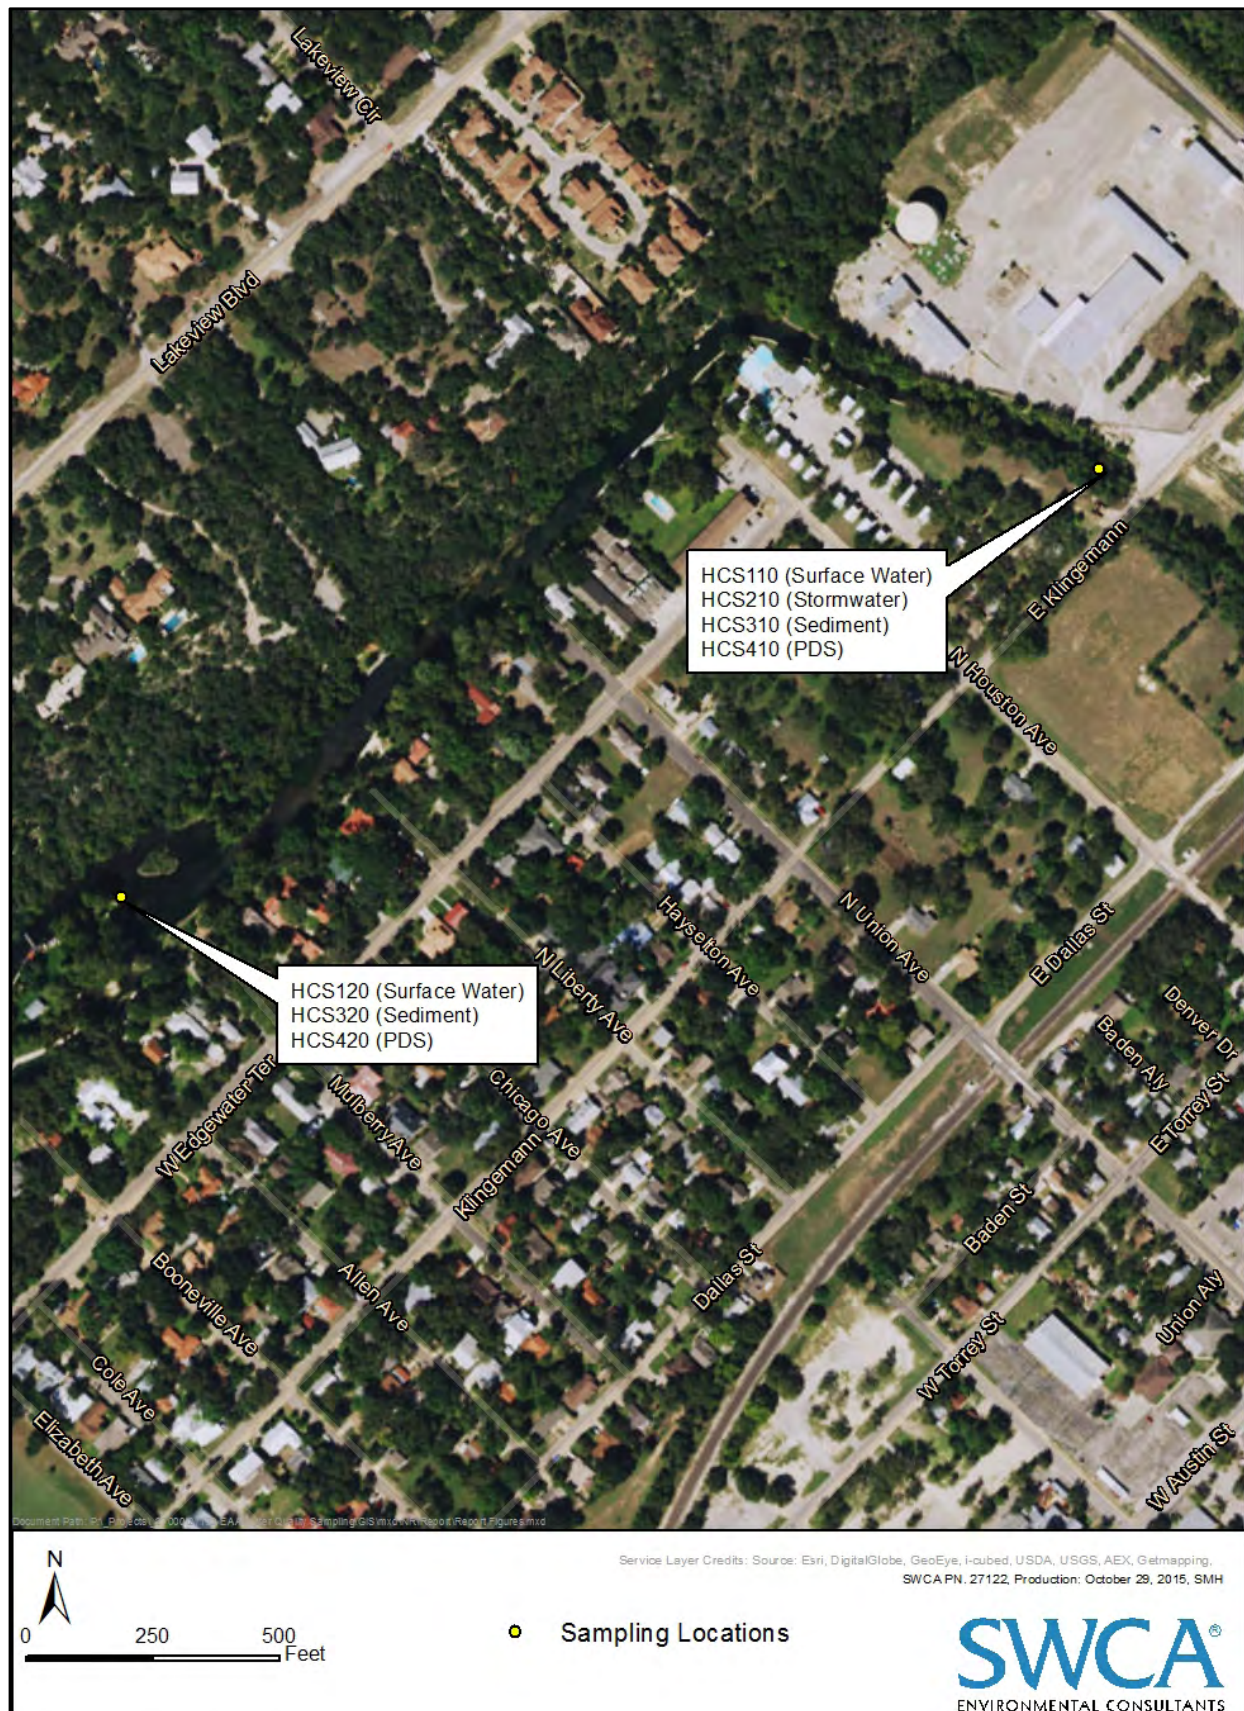
**Figure 3. EAHCP Comal Springs detailed map indicating sample locations 110, 210, 310, 410, 120, 320 and 420.**

Details of individual sample locations are provided in the following figures. Figures 3–6 show sample location details for the Comal Springs area. Figures 7–10 provide sample location details for the San Marcos Springs area.

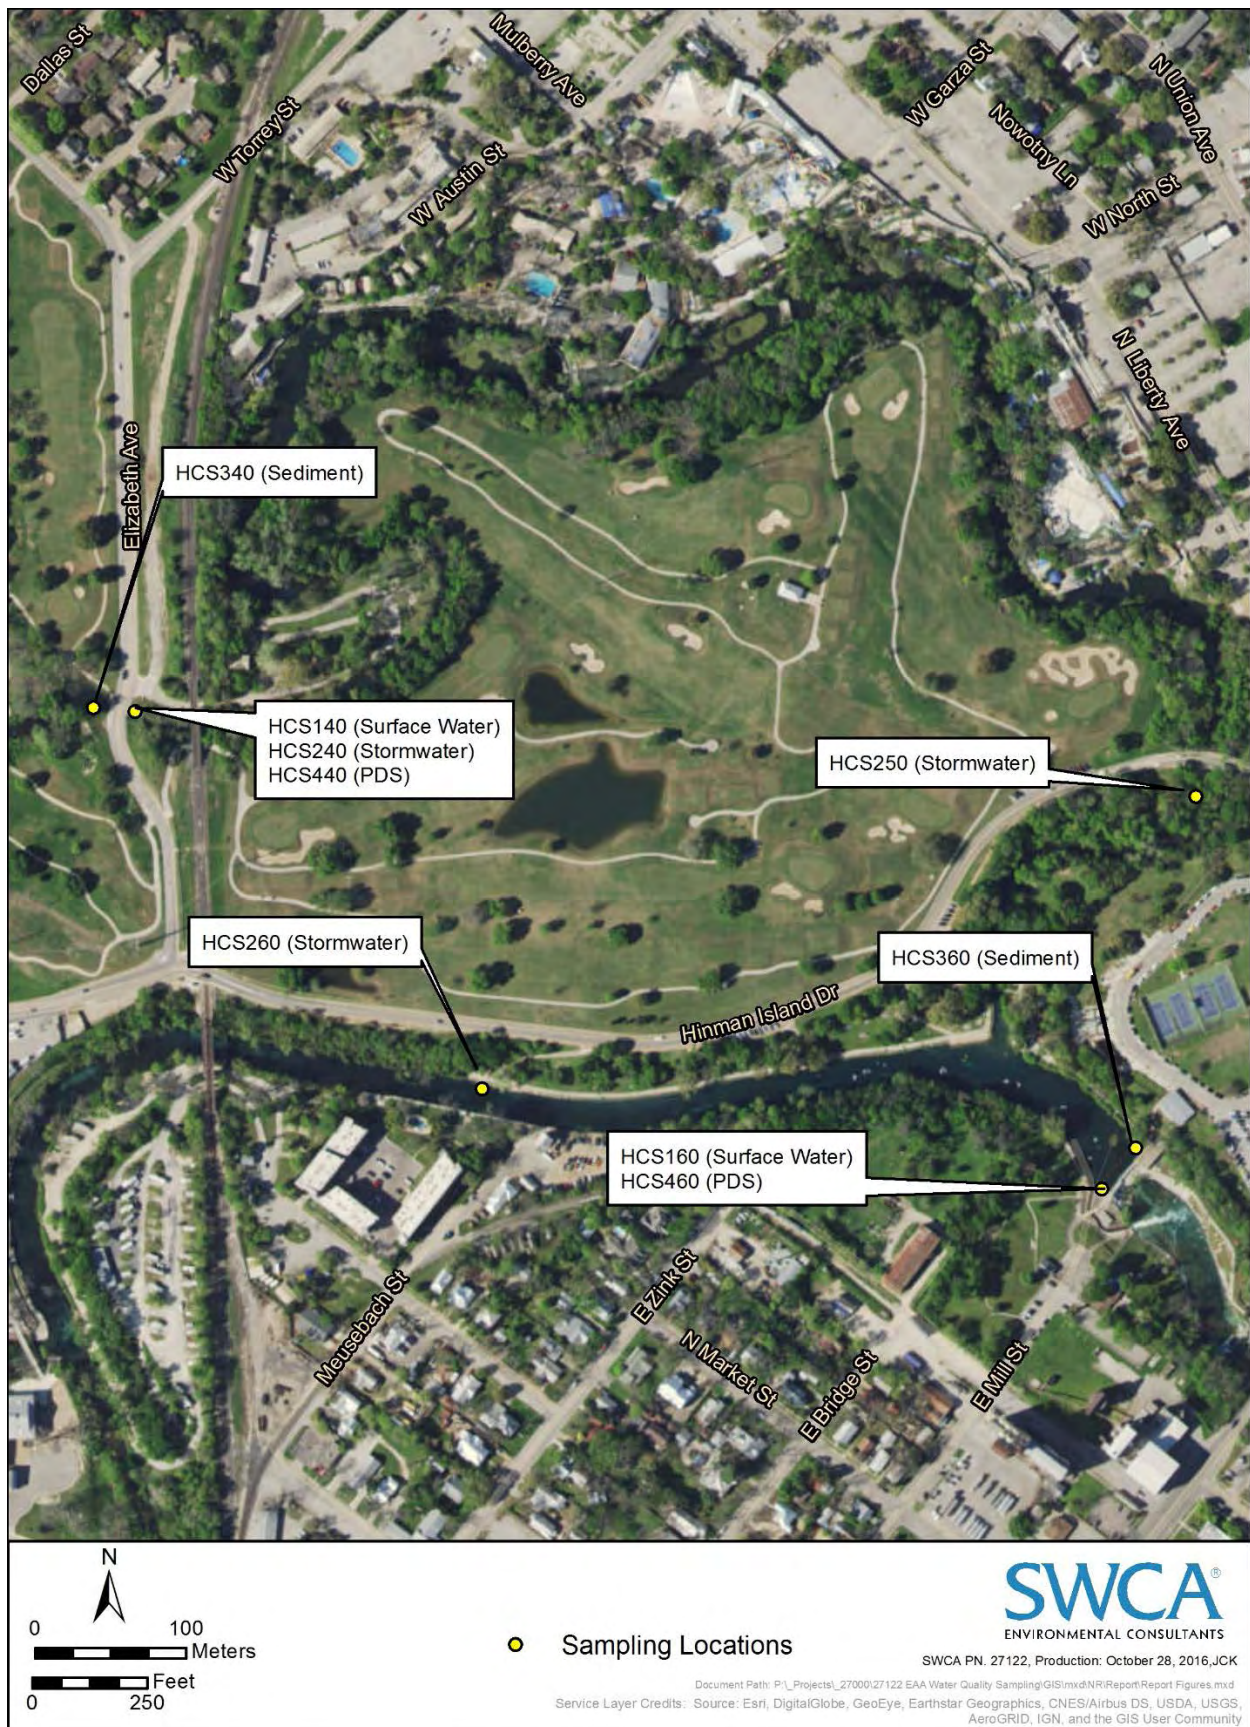
**Figure 5. EAHCP Comal Springs detailed map indicating sample locations 140, 240, 340, 440, 250, 160, 260, 360 and 460.**

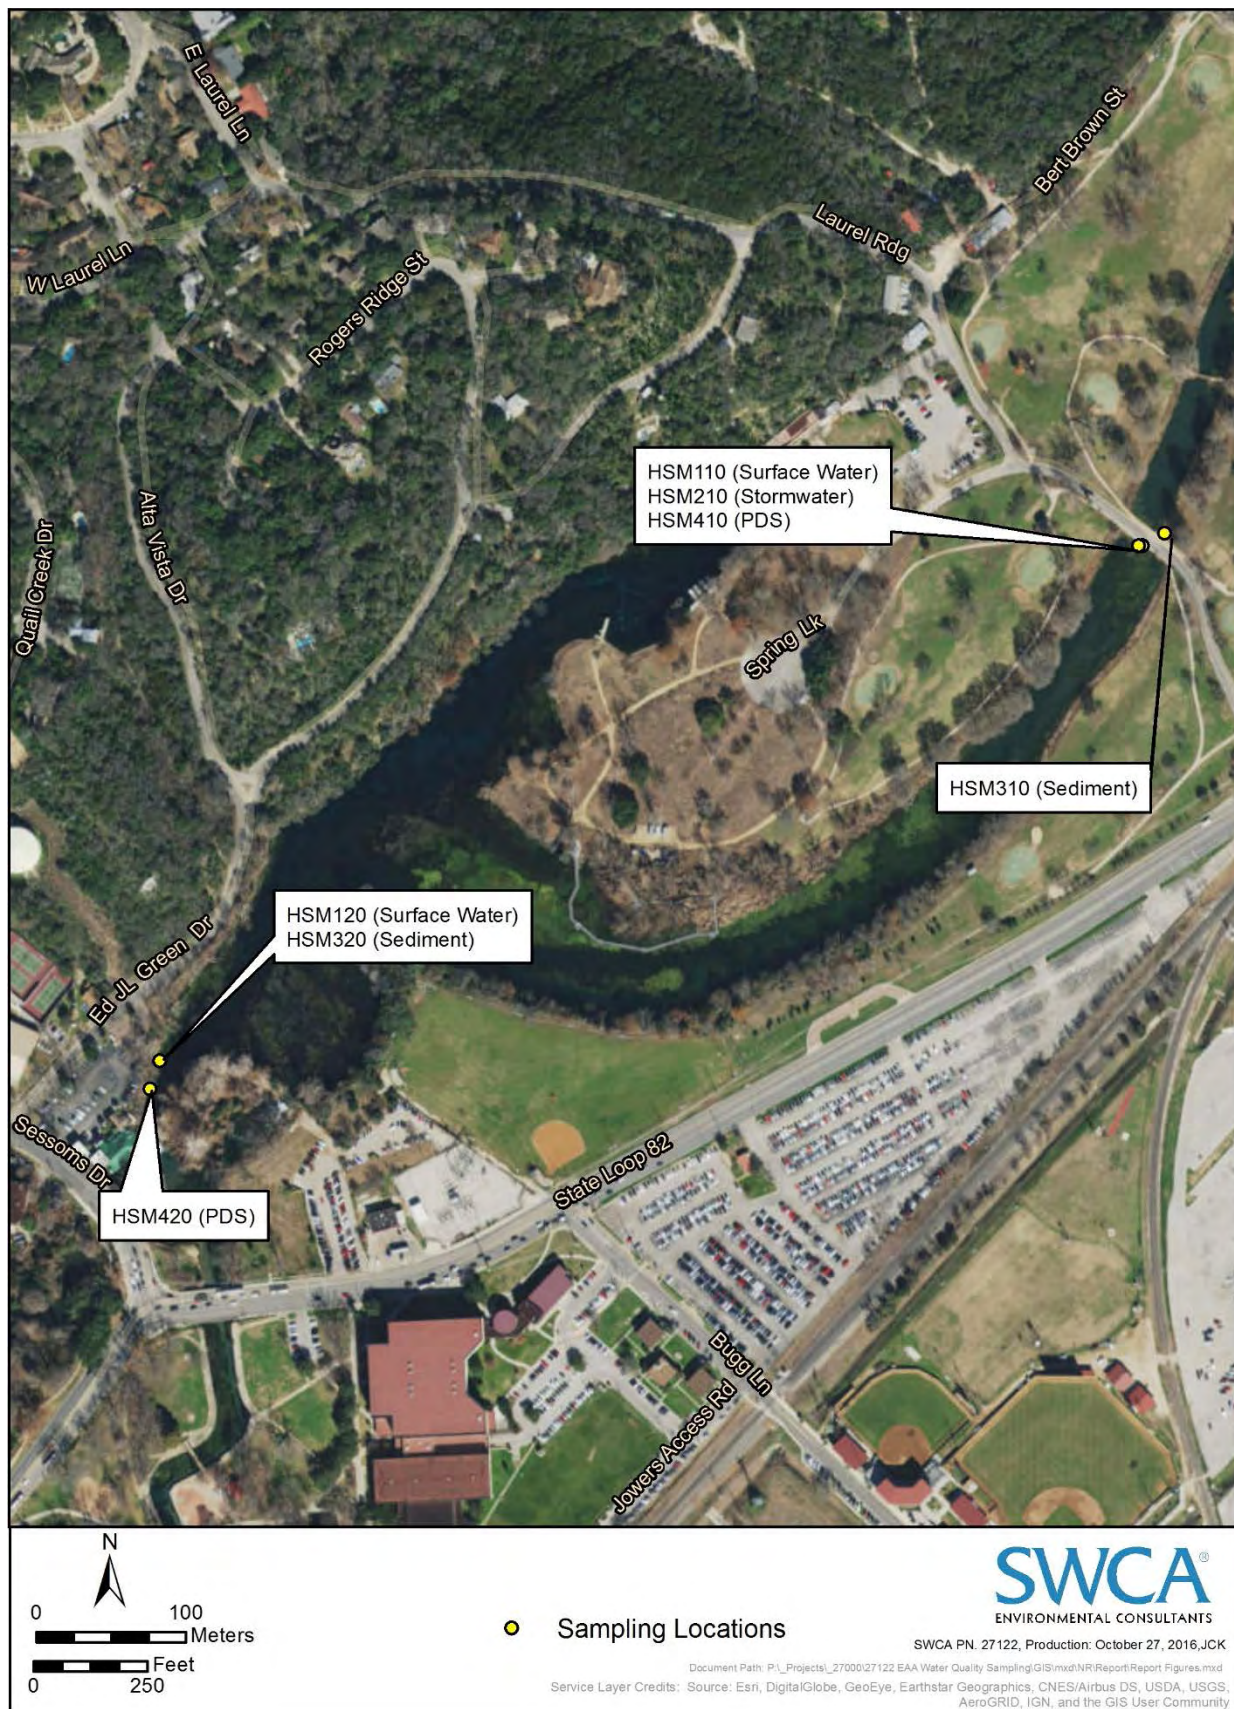
**Figure 7. EAHCP San Marcos Springs detailed map indicating sample locations 110, 210, 310, 410, 120, 320 and 420.**

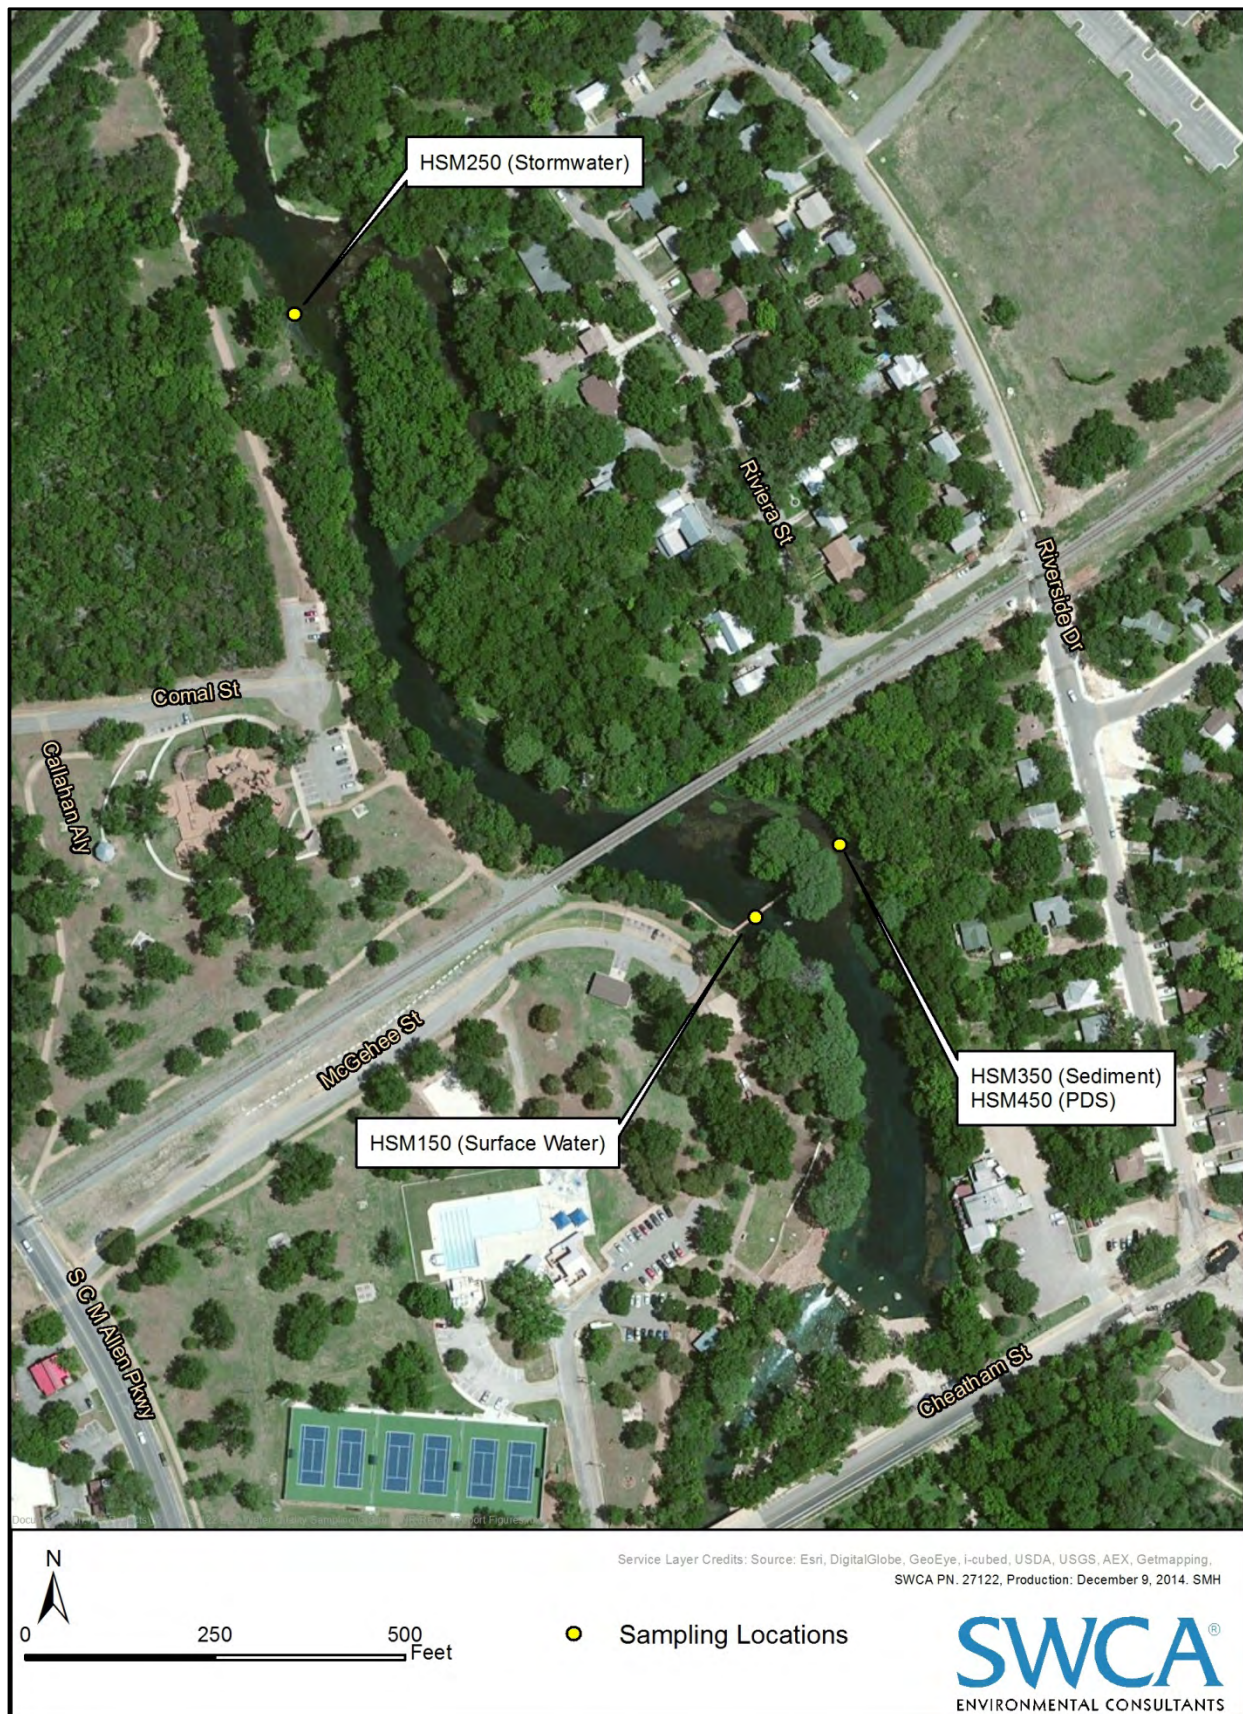
**Figure 9. EAHCP San Marcos Springs detailed map indicating sample locations 150, 250, 350 and 450.**

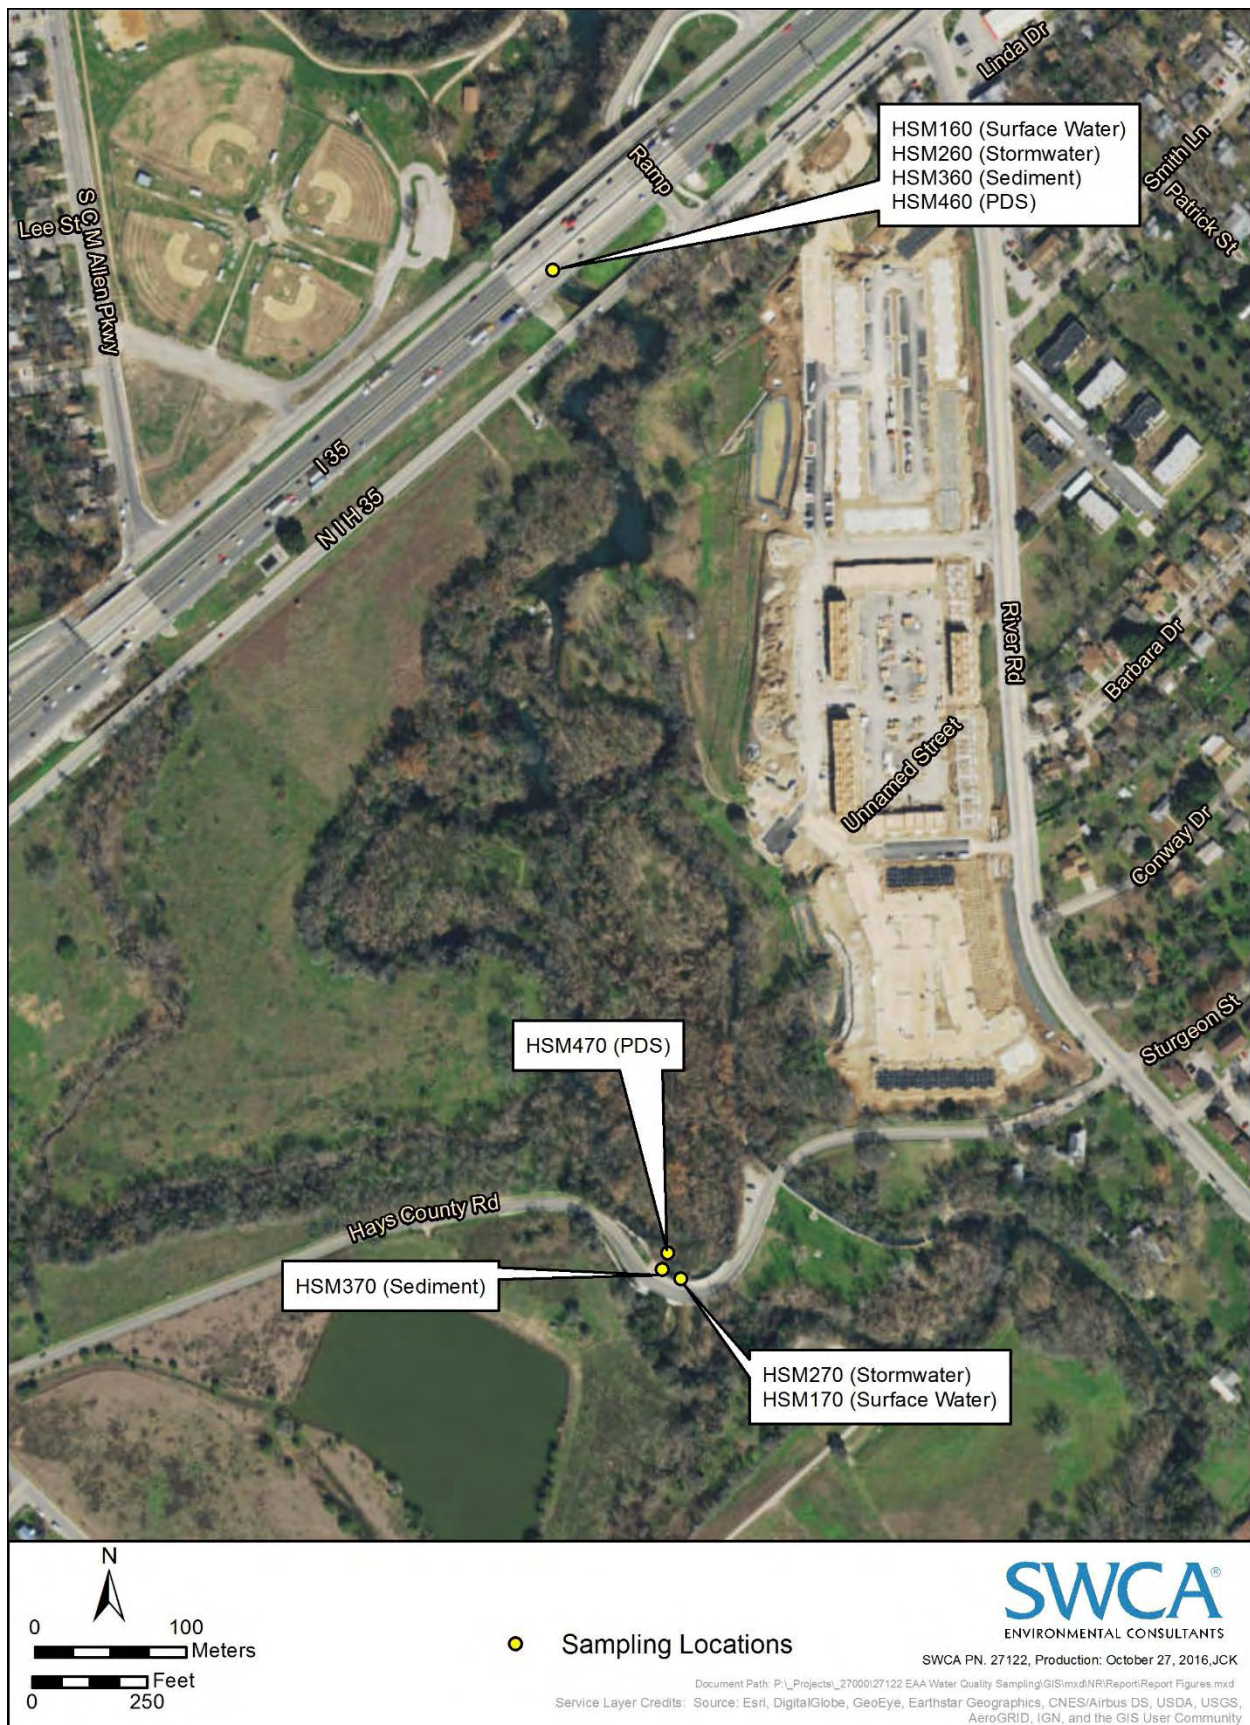
**Figure 10. EAHCP San Marcos Springs detailed indicating map sample locations 160, 260, 360, 460, 170, 270, 370 and 470.**

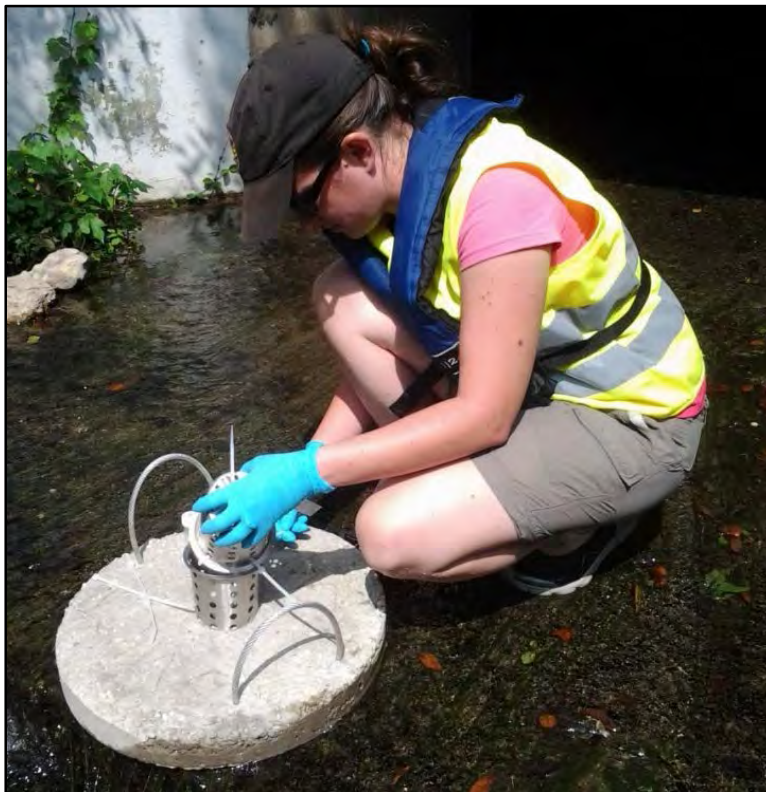
SWCA staff constructed deployment devices at SWCA's San Antonio office in June 2014. Two-inch thick, 18-inch diameter concrete disks were poured and a stainless steel silverware cup was set approximately one inch deep in the center of the disk. Handles were formed by inserting both ends of an 18-inch length of vinyl-coated stainless steel cable into each side of the disk. Site numbers were marked in the wet concrete to dedicate each device to a sample location. The concrete was allowed to cure, and each device was decontaminated following the *EAA Groundwater Quality Monitoring Plan* guidelines and placed in a clean plastic bag prior to the first deployment. The same decontamination procedures were followed for subsequent sampling events. SWCA constructed additional deployment devices in 2016 to replace devices lost or damaged in the field. The deployment device is pictured in Figure 11.

Upon arrival at the sample location, the PDS was removed from a dedicated vial and affixed inside of a second stainless steel silverware cup with a plastic cable tie. This cup was inverted and placed on top of the cup set in the concrete sampling device enclosing the PDS inside the two cups. The two cups were secured to one another with additional plastic cable ties. The device was then gently lowered into the water. Installation date and time and PDS identification numbers were noted in the field notebook and on the PDS vial. To retrieve the PDS, the devices were simply removed from the water and the cable ties cut. The PDS was then immediately placed back in the dedicated vial and retrieval date and time were notated. Deployment devices were secured at SWCA offices when PDSs were not deployed.

**Figure 11. PDS deployment device prior to installation at site HSM440.**
